TURBOMACHINERY SYMPOSIUM

CASE STUDY

‘BALANCE INSTABILITY AND VIBRATION ON A 6 MW INDUCTION MOTOR ROTOR’

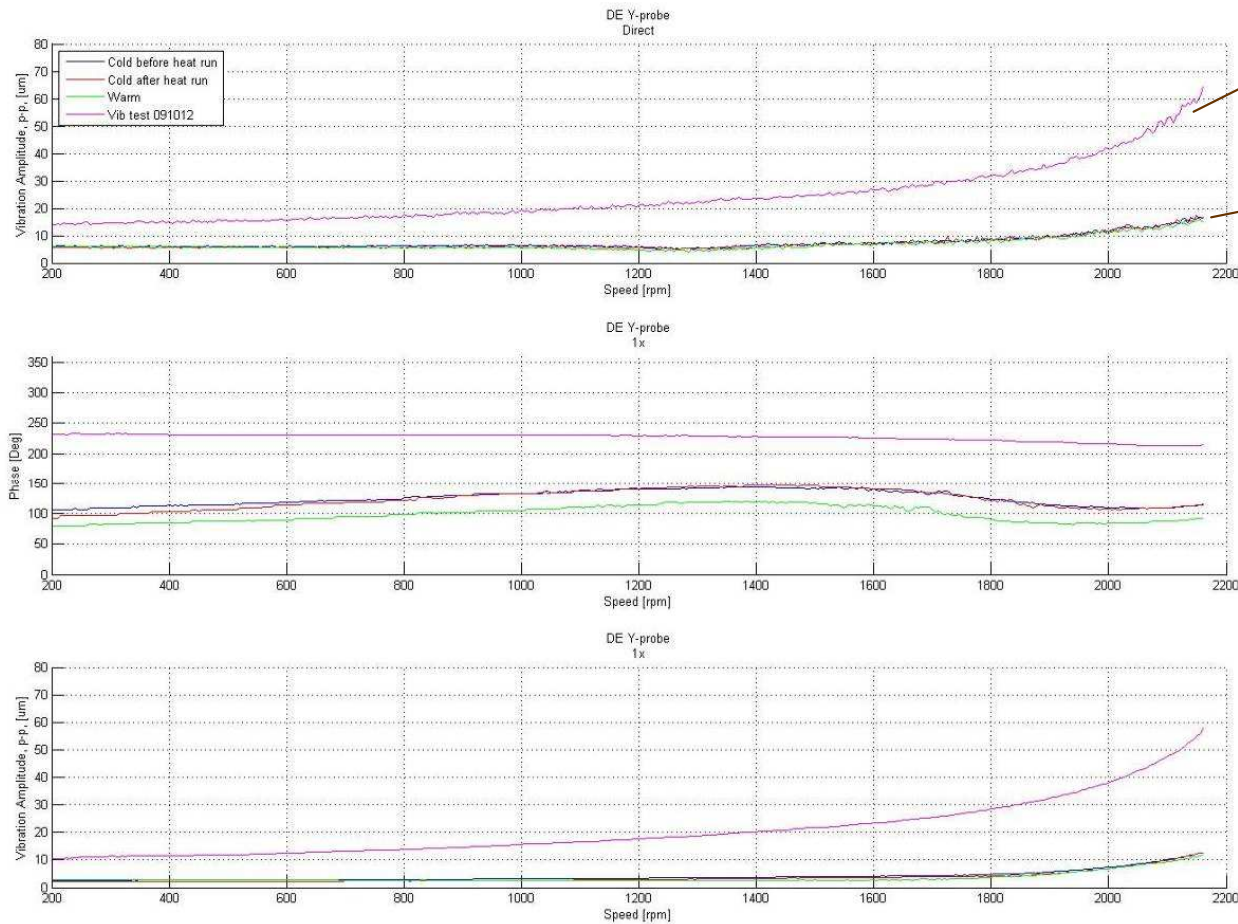
New Rotor: Residual Unbalance & Vibration Tests

Old rotor

New rotor

- It is very difficult to correct a rotor after a distorted cooling or skewed lamination fit on the rotor core
- Trial and error attempts to diagnose and repair this type of rotor problem can be very time consuming and without guarantee of success.
- In a schedule oriented environment, it is important to have all the necessary resources involved to quickly determine if the problem can be corrected and a quality machine assured. Sometimes it may be necessary to move in parallel in attempting to repair the rotor and preparing to manufacture a new rotor.

Manufacturing of new rotor with changed manufacturing process for the core shrinking
